# Mapping Submerged Features at Ada Estuary Using Side Scan Sonar: A Multi-Instrumental Approach to Riverbed Characterization

Sebastian Senyo BOTSYO<sup>1</sup>, Tengan Yvonne ENYELKO-ANU<sup>1</sup>, Jafar Ali ABDUL<sup>1</sup>,  
Yahaya Hafiz NUBANIE<sup>1</sup>, Clement KUUNUORING<sup>1</sup>, Issac BLEBOO<sup>2</sup>

<sup>1</sup>Ghana School of Surveying and Mapping, Accra, Ghana

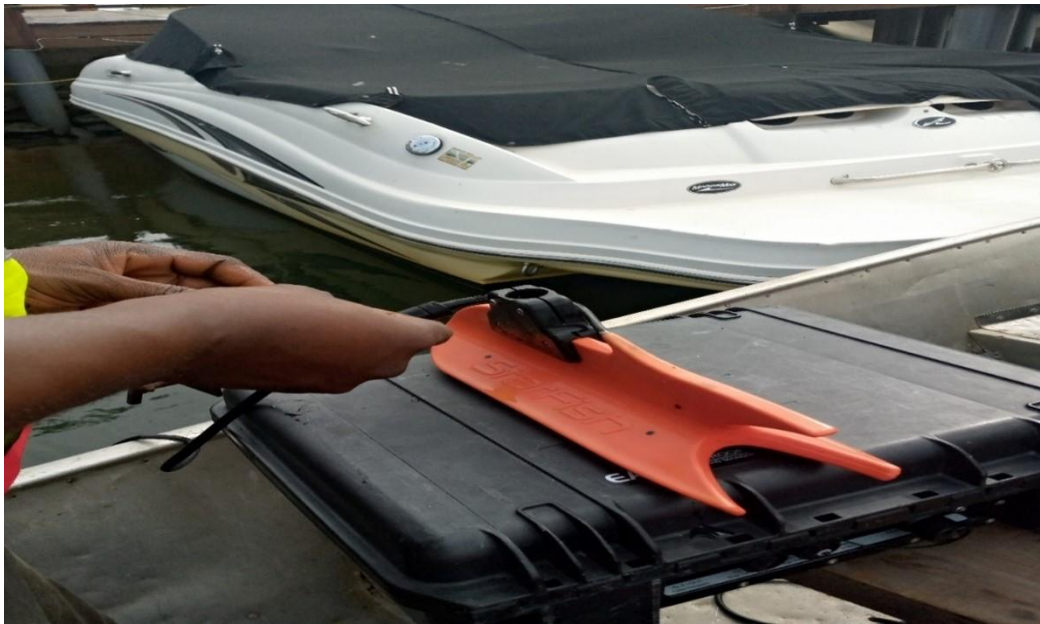
**Side Scan Sonar System:** A StarFish side scan sonar unit was deployed for underwater feature detection and imaging. The system operated through direct cable connection to the survey computer, enabling real-time data visualization and recording.

*Figure 2: StarFish Side Scan Sonar Unit*

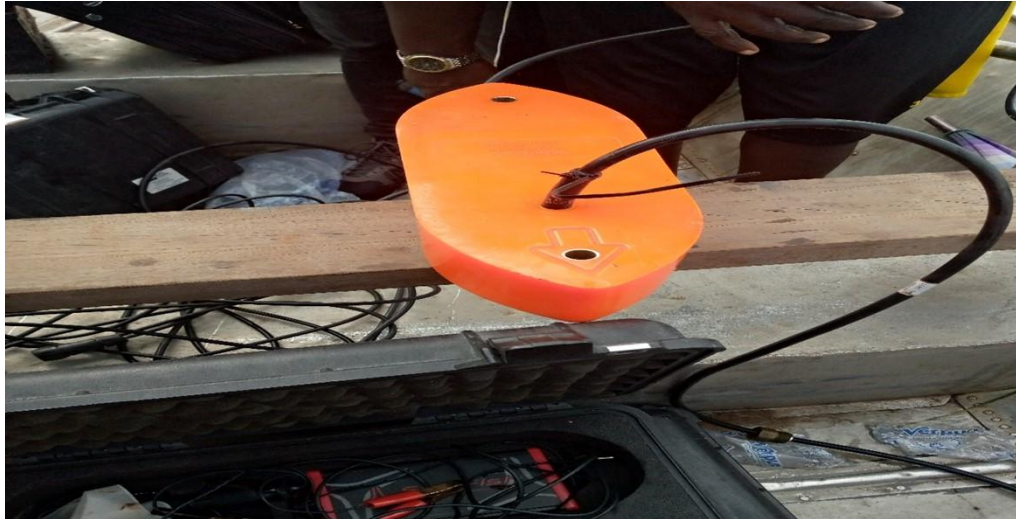
**Echo Sounder:** Depth measurements were obtained using a calibrated echo sounder system for bathymetric data collection. The instrument transmitted acoustic pulses to the riverbed with depth calculations based on two-way travel time measurements.

*Figure 3: The Kongsberg EA440SP Dual Frequency (38/200 KHz) Single Beam Echo Sounder*
