# **Bathymetric Multibeam and Aerial Lidar Survey of Wemmershoek Dam: Accuracy Assessment, Volume Analyses and Heritage Insights**

**James PARKES and Jonathan DINGLE, South Africa**

**Key words:** Bathymetry, Multibeam Sonar, Lidar, Survey, Dam Volume Analyses, Heritage

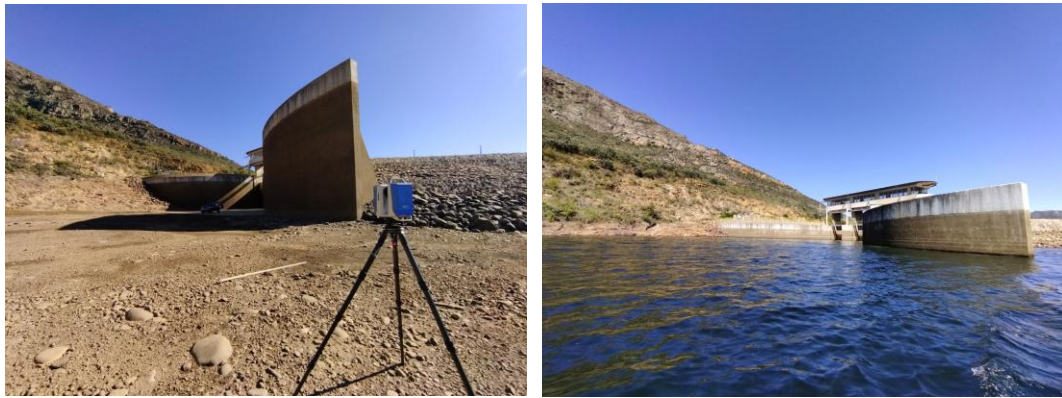
Figure 2 shows the difference in dam levels between the two site visits. The full supply level is also visible as a dark stain on the spillway wall.

**Figure 2.** left TLS Scan at 50% capacity; right second MBES survey at 85% capacity

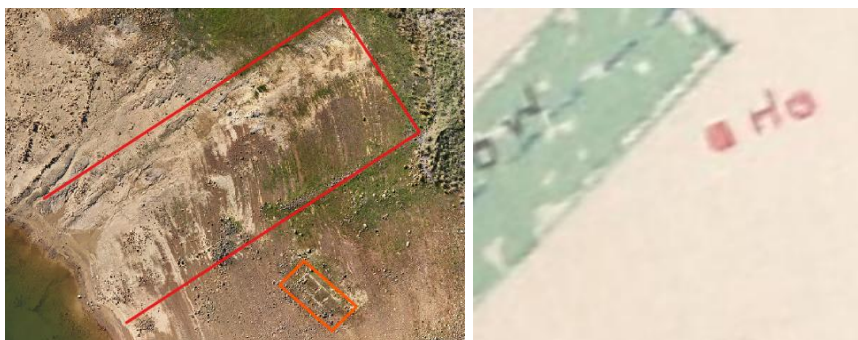
**Figure 13.** Garden Ground Free Hold (Pritchard, 1901)

Figure 13 depicts the remains of the long field and house visible in both the diagrams. The 1896 diagram for this area indicates it was “Garden Ground Free Hold”. Once pointed out the feature is obvious, though it demonstrates how hidden a historical object can be.

The earliest document obtained for the area that is of interest is the 1896 diagram for Farm 870 (R.J.Moll, 1896) and the 1901 cadastral diagram for Farm 873 (Pritchard, 1901). These diagrams show wooded areas, farmed fields, housing positions, and a notable fountain. The fountain suggests a spring being present, no doubt still contributing to the water supply. The 1901 diagram is a ‘redline’ diagram indicating that survey errors can be expected, however it can be used as guide to the identification of features.
